AFML-TR-70-213

**INVESTIGATION OF THE PROPERTIES OF  
CARBON-CARBON COMPOSITES  
AND THEIR RELATIONSHIP TO  
NONDESTRUCTIVE TEST MEASUREMENTS**

*McDONNELL DOUGLAS ASTRONAUTICS COMPANY*

TECHNICAL REPORT AFML-TR-70-213, PART II

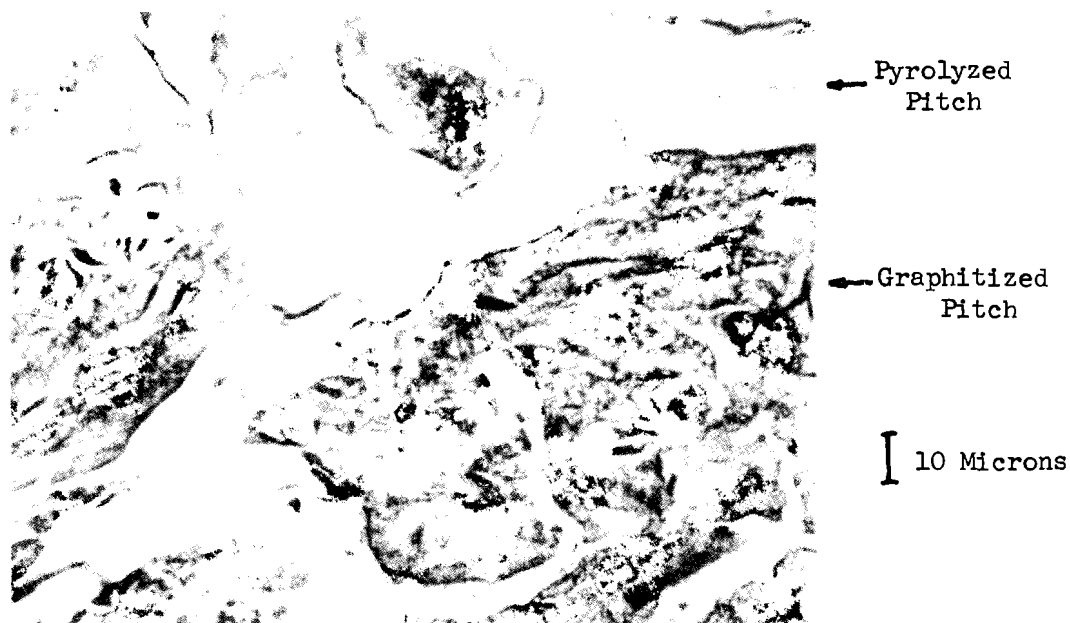
Figure 20. Photomicrograph of Multidirectional Composite After Two Impregnations and Pyrolysis - Graphitization - Three Impregnations

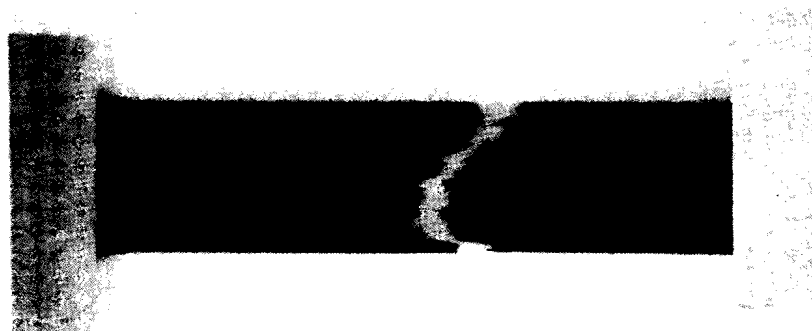
Figure 73. Failed Tensile Specimens of Pyrolyzed VYB 70 1/2-SC1008 Composite Using Current Specimen Design

Initial tension testing of the pyrolyzed VYB 70 1/2 - SC1008 composites involved the strip tensile specimen design. This design was unsatisfactory since failure occurred at the doublers. At this point, the specimen configuration was changed to a dogbone specimen reduced in the thickness direction as shown in Figure 72. This design combines the features of strip specimen with the advantage of a reduced gage section. By reducing the thickness rather than the width, it was possible to use a large fillet radius that reduced the stress concentration at the fillet. Failed tensile specimens using this current design are shown in Figure 73. Failure occurred in the center of the gage section in all cases. This specimen design also resulted in higher strength values as shown in Table XXIII. The doubler material selected was aluminum, rather than steel as previously used, so that a closer matching of transverse moduli between the specimen and the doubler could be provided.

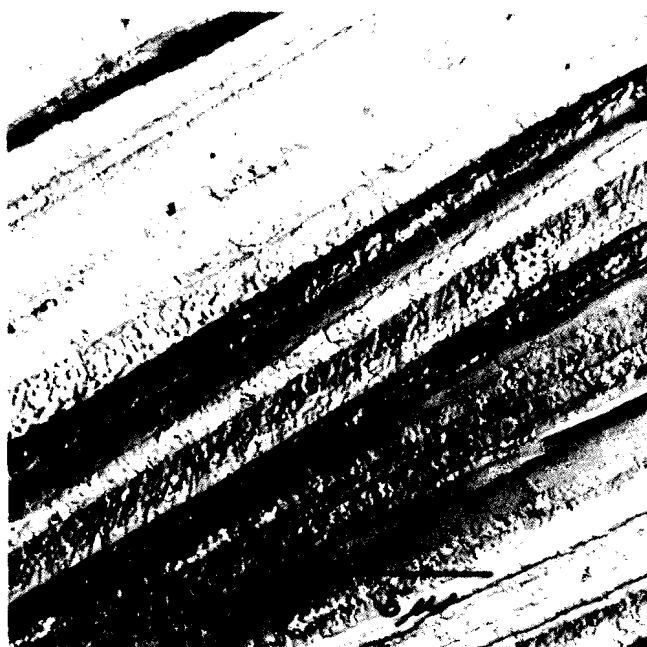
Figure 92. Electron Fractographs of Graphitized VYB 70 1/2-SC1008 Tensile Specimen 14A3

The results indicated that the higher strength specimen (14A3) had a larger amount of yarn-matrix bonding taking place than the lower strength specimen (10A5). This was indicated by the large amount of matrix remaining on the filament surface of specimen 14A3 as shown in the electron fractographs of Figures 92 and 93. The black areas or spots in the micrographs are folds in the plastic replica or dust particles from the fracture surface. The VYB 70 1/2 filament diameter is approximately 6.0 microns. The scanning electron micrographs of specimens 10A5 and 10A3 are shown in Figures 94 and 95. These results indicated the importance of the yarn-matrix bond or specifically the wetting of the yarn by the matrix. Electron fractographs of the VYB 70 1/2 filament showed the brittle filament fracture present in both these composite specimens (Figure 96).

On comparing the electron fractographs of the pitch and SC1008 binders, it was apparent that the pitch binder did indeed wet the filaments to a greater degree than the SC1008 binder. This is shown most clearly in Figure 101, 92, and 93.

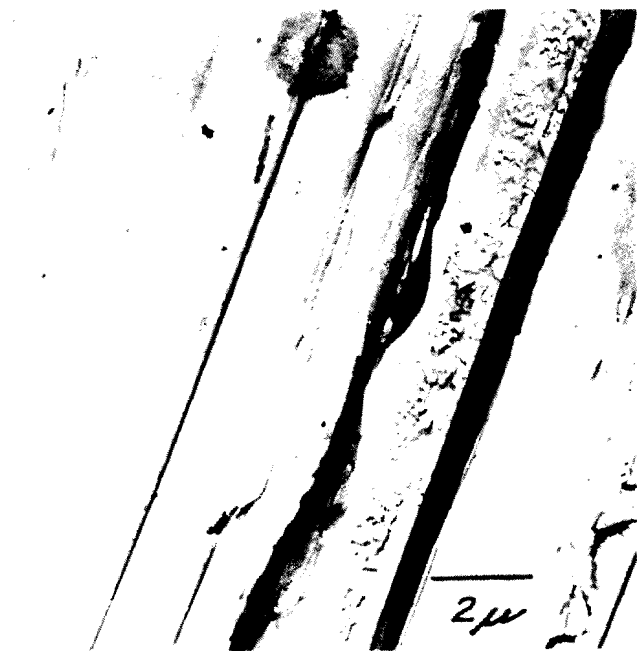
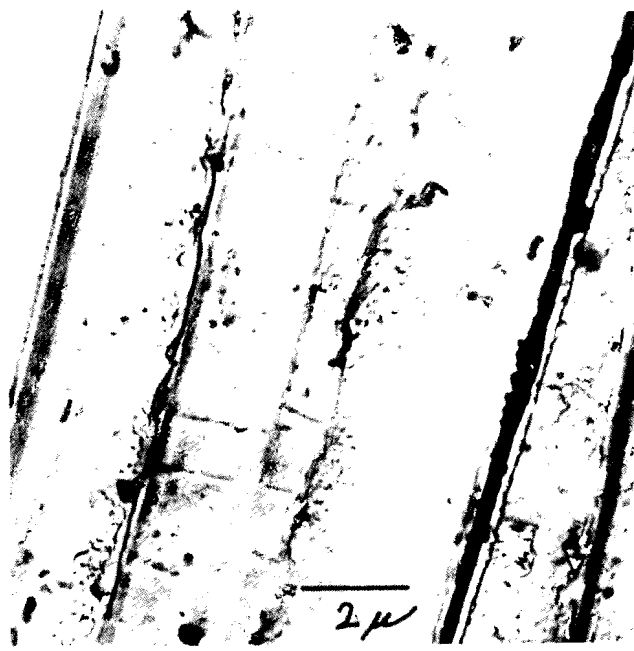
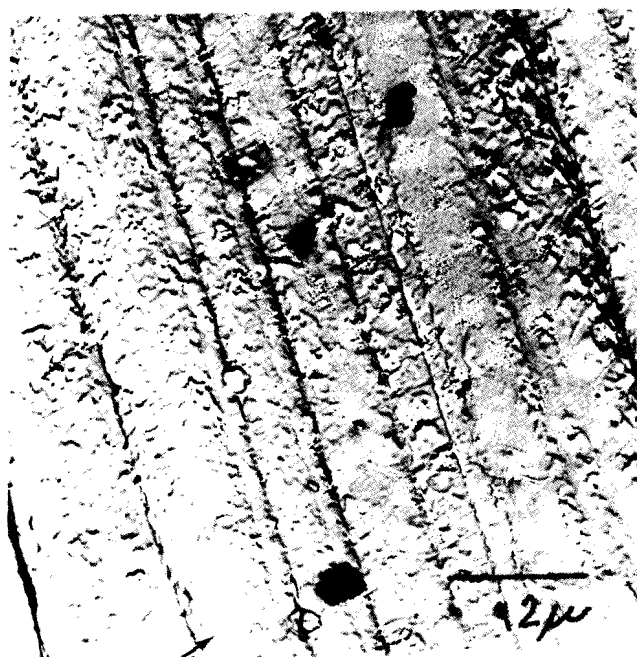
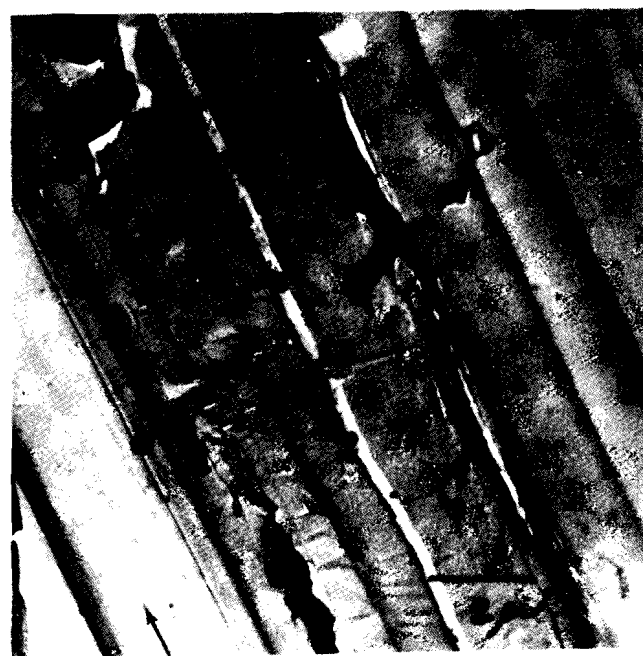
Figure 93. Electron Fractographs of Graphitized VYB 70 1/2-SC1008 Tensile Specimen 10A5

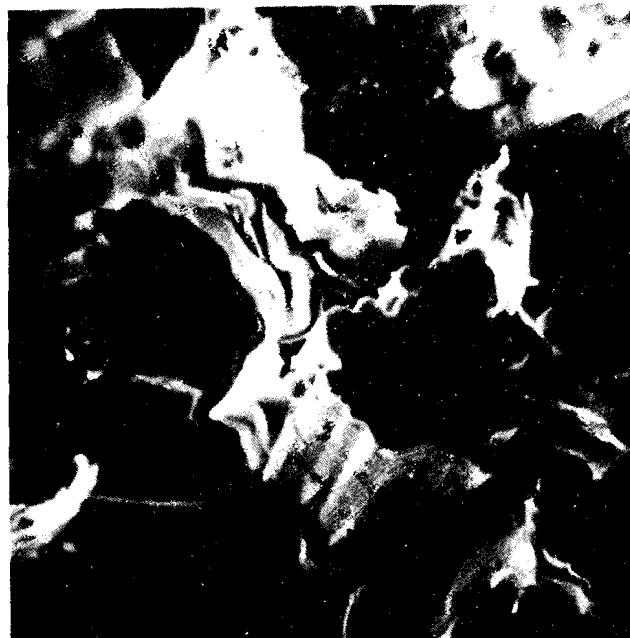
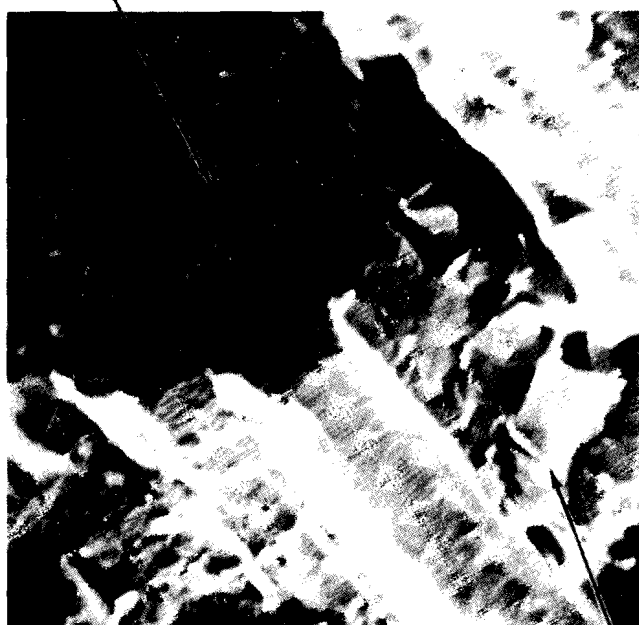
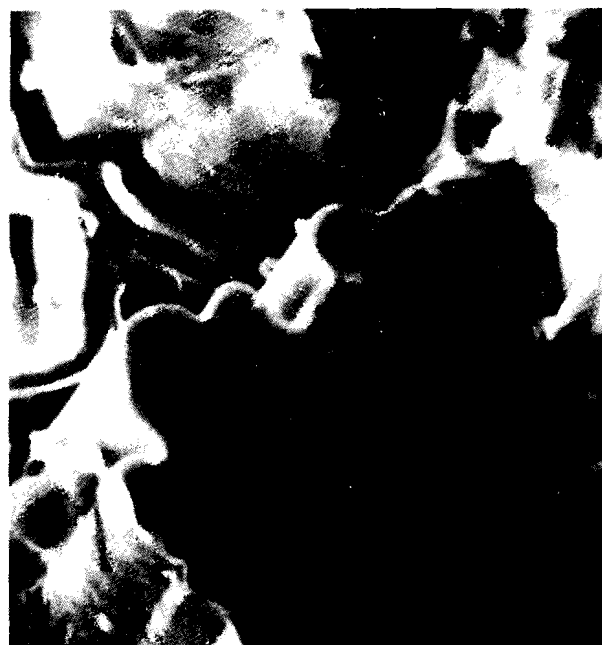
Figure 95. Scanning Electron Micrographs of Graphitized  
VYB 70 1/2-SC1008 Tensile Specimen 10A5.

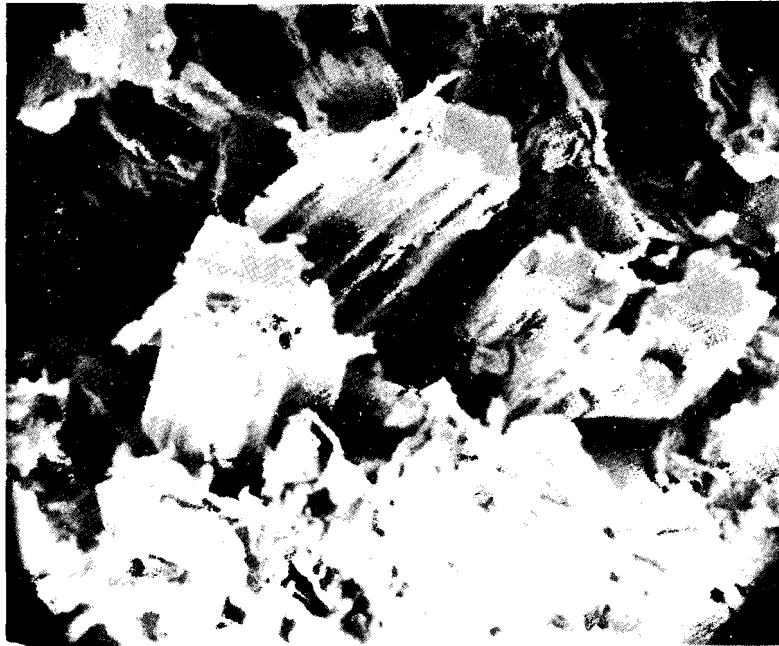
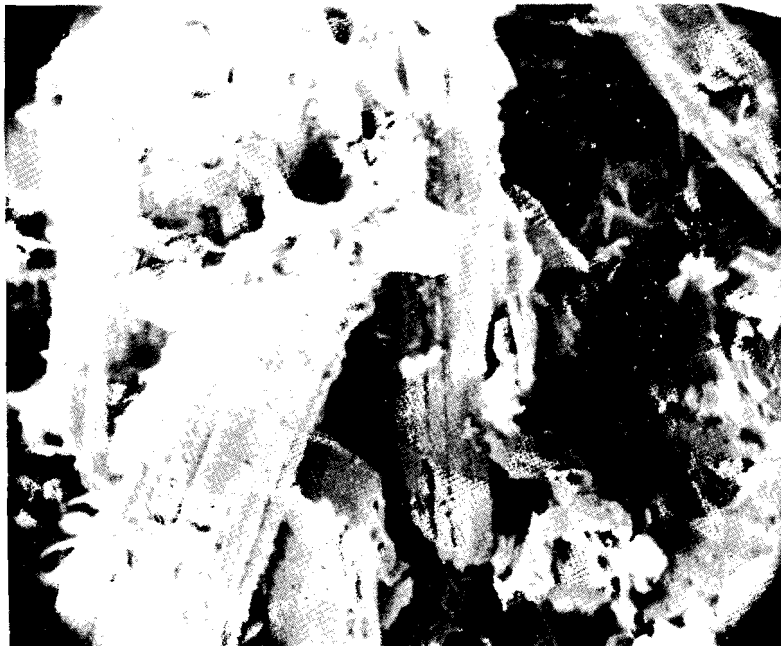
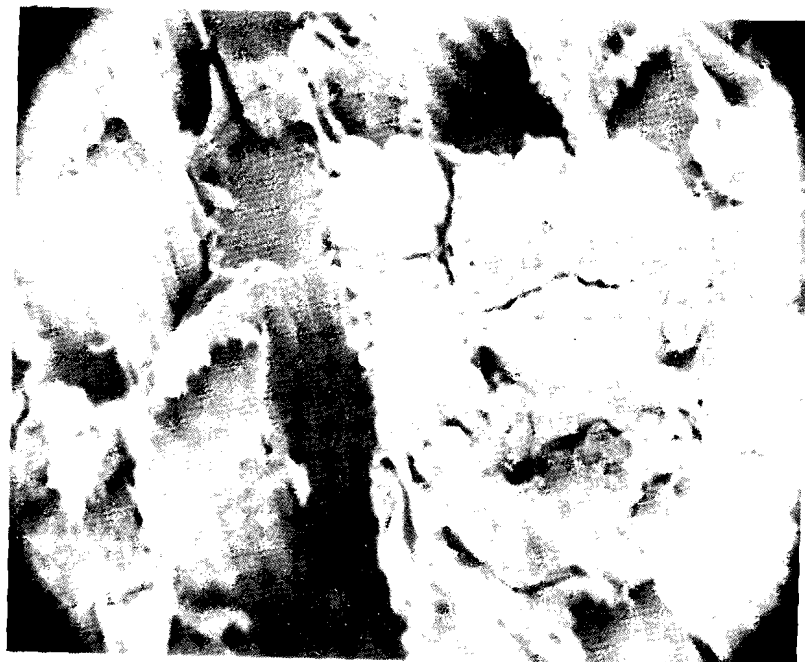
Figure 98. Scanning Electron Micrographs of Graphitized VYB 70 1/2-Pitch Tensile Specimen

From the SEM pictures, there was evidence of multiple fracture within a single filament (along its length) for the no-intentional defect specimen (Figure 98). There were numerous short lengths of filaments that were in different orientations. In contrast, the micrographs of the small void specimen showed no mis-oriented broken filaments (Figure 99).

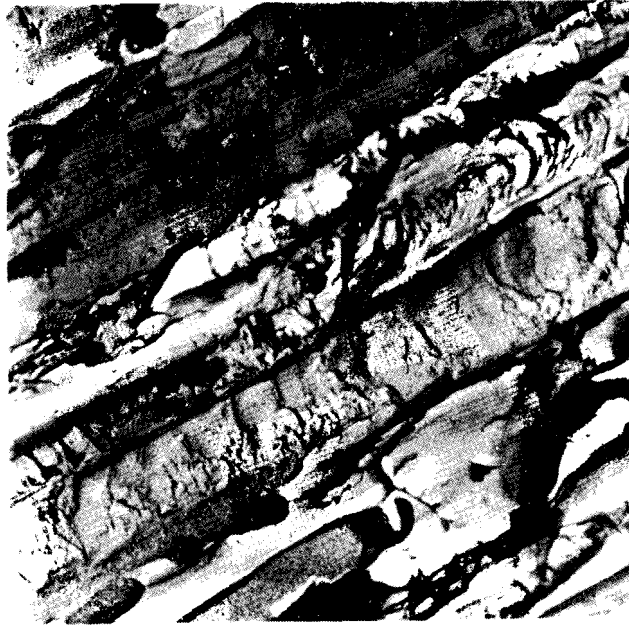
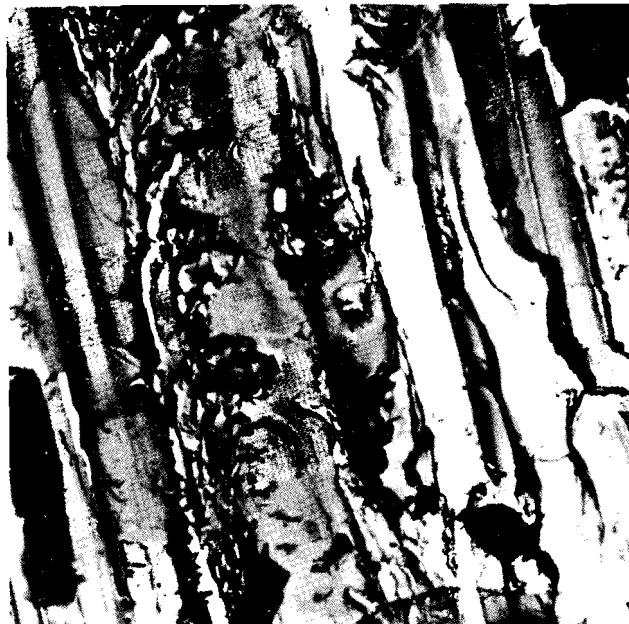
Figure 100. Scanning Electron Micrographs of Graphitized  
VYB 70 1/2-Pitch Tensile Specimen

No-Intentional-  
Defect Specimen

Small Void  
Specimen

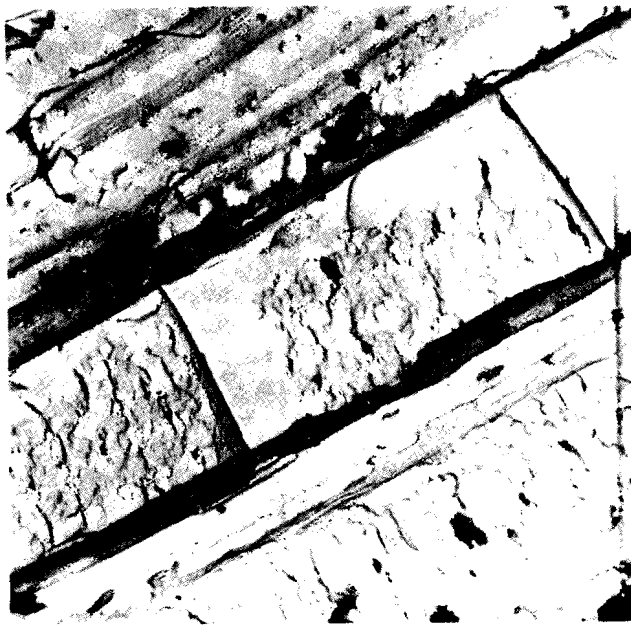
Figure 102. Electron Fractograph of Graphitized VYB 70 1/2-Pitch  
Tensile Specimen

Local cracking of the pitch binder is shown on Figure 102 where the orientation of the cracking was normal to the axis of the filaments. It appears that the two cracks across the matrix segment do not propagate into the adjacent filaments. In the top portion of the figure, this may be due to a separation between the matrix and yarn prohibiting any penetration.
